DIMENSIONAL RESTORATION OF
HIGH - VALUED MILITARY
COMPONENTS USING KINETIC
METALLIZATION™

Ralph Tapphorn, Howard Gabel and Travis Crowe

ITSC 2015 Presentation

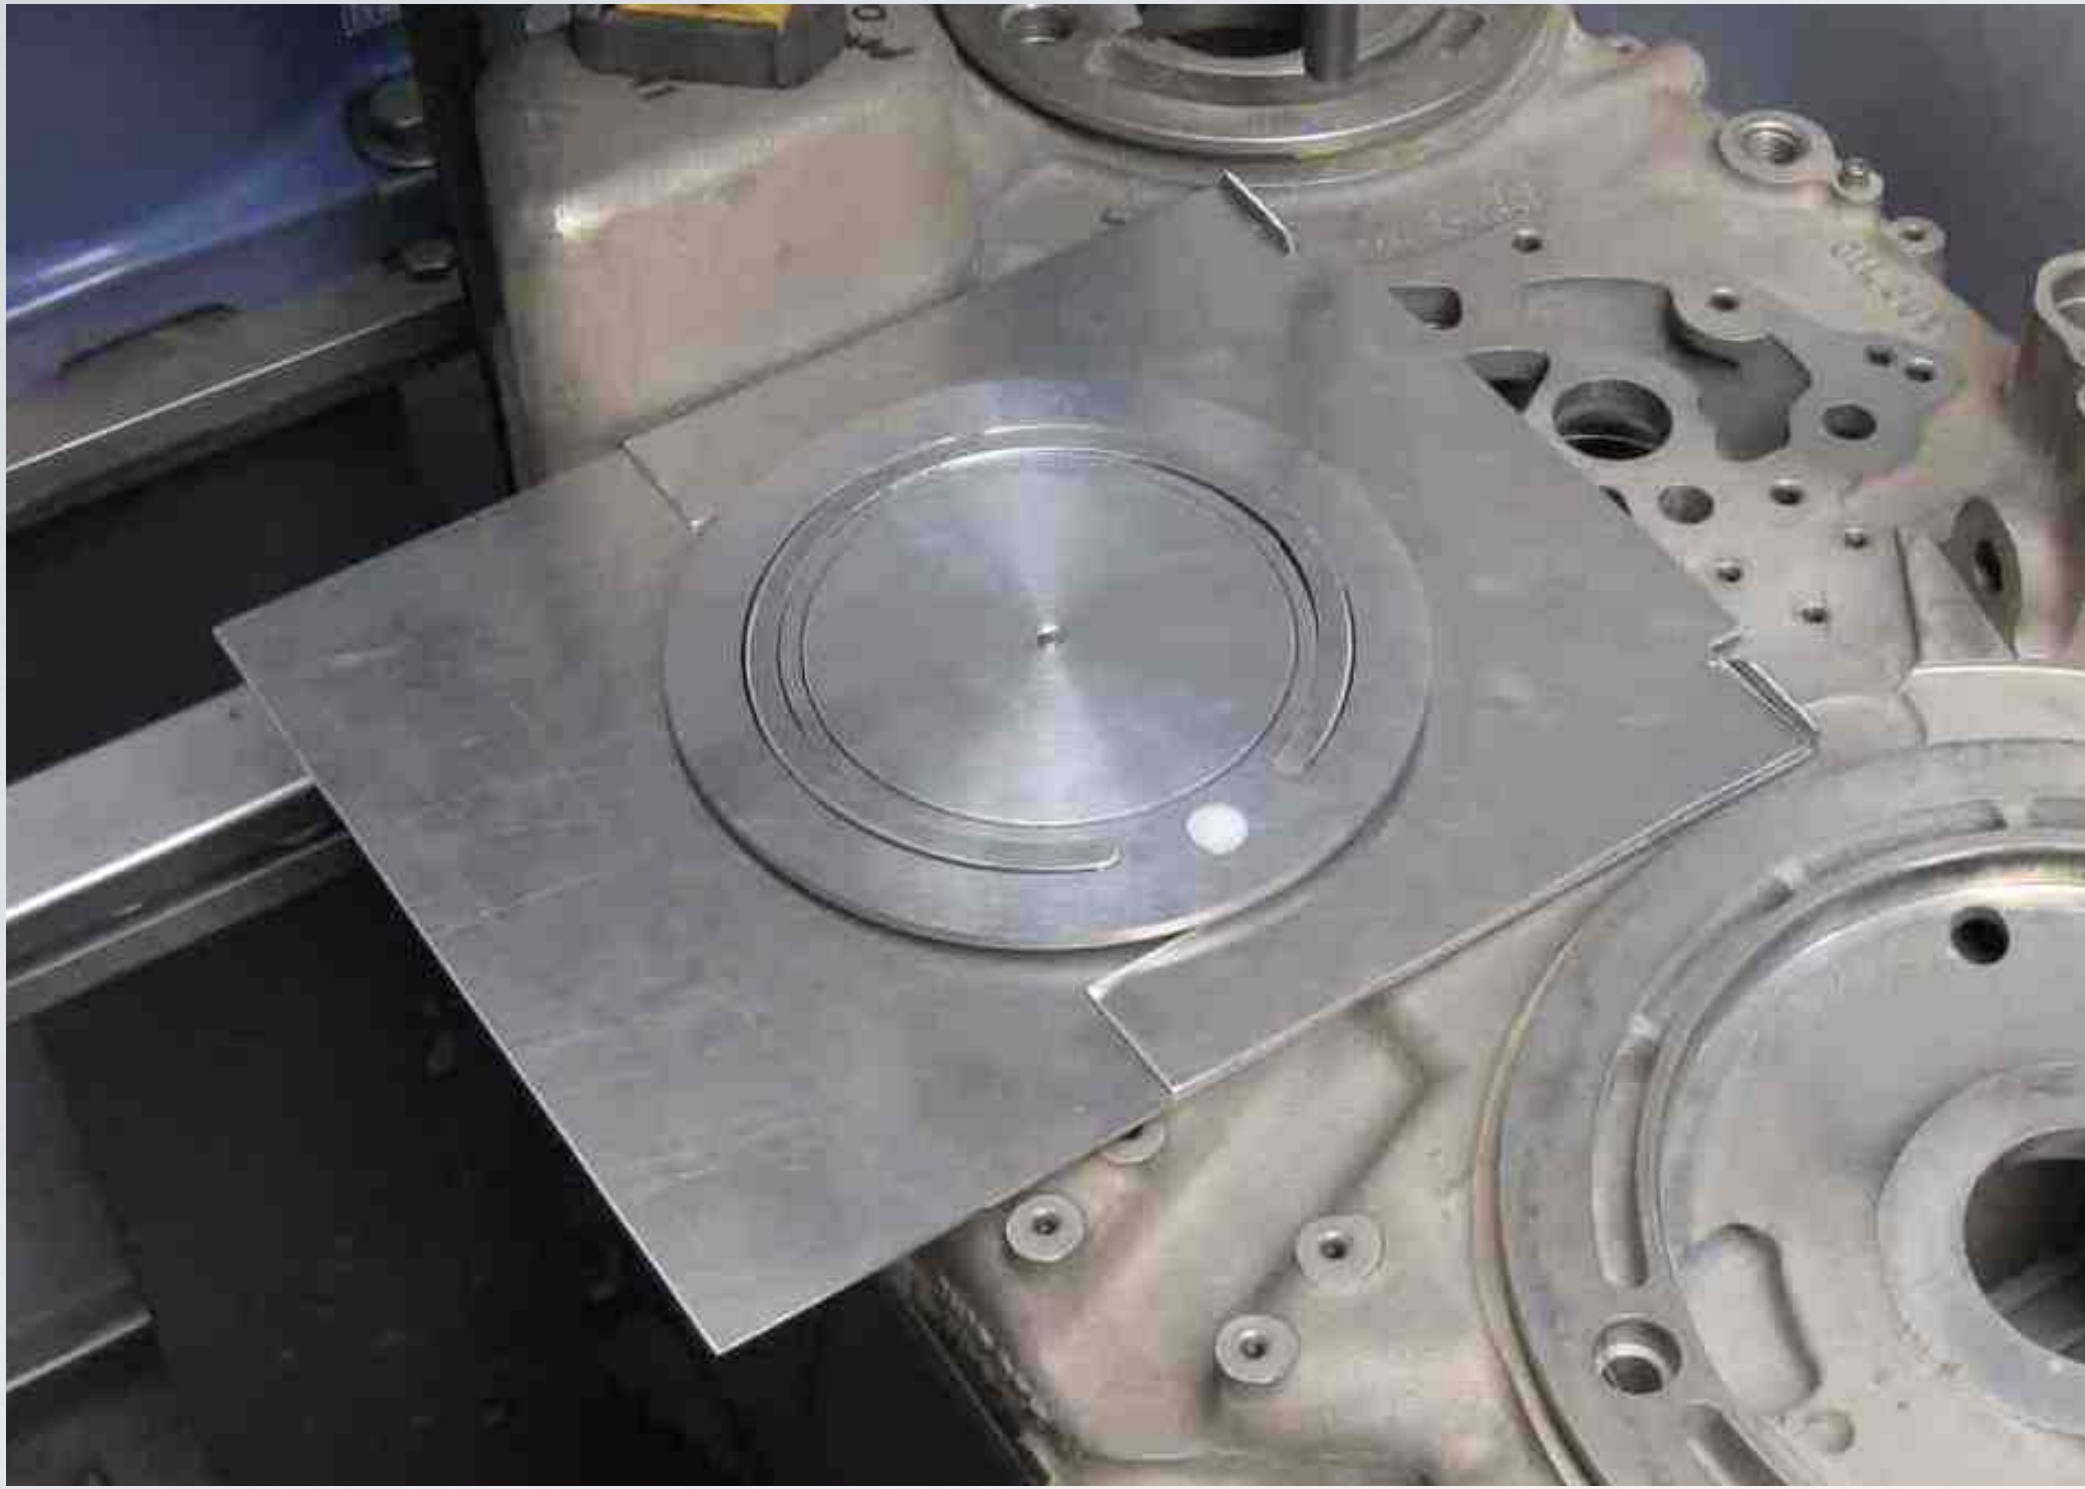
MASK

FRETTING HYDRAULIC PAD

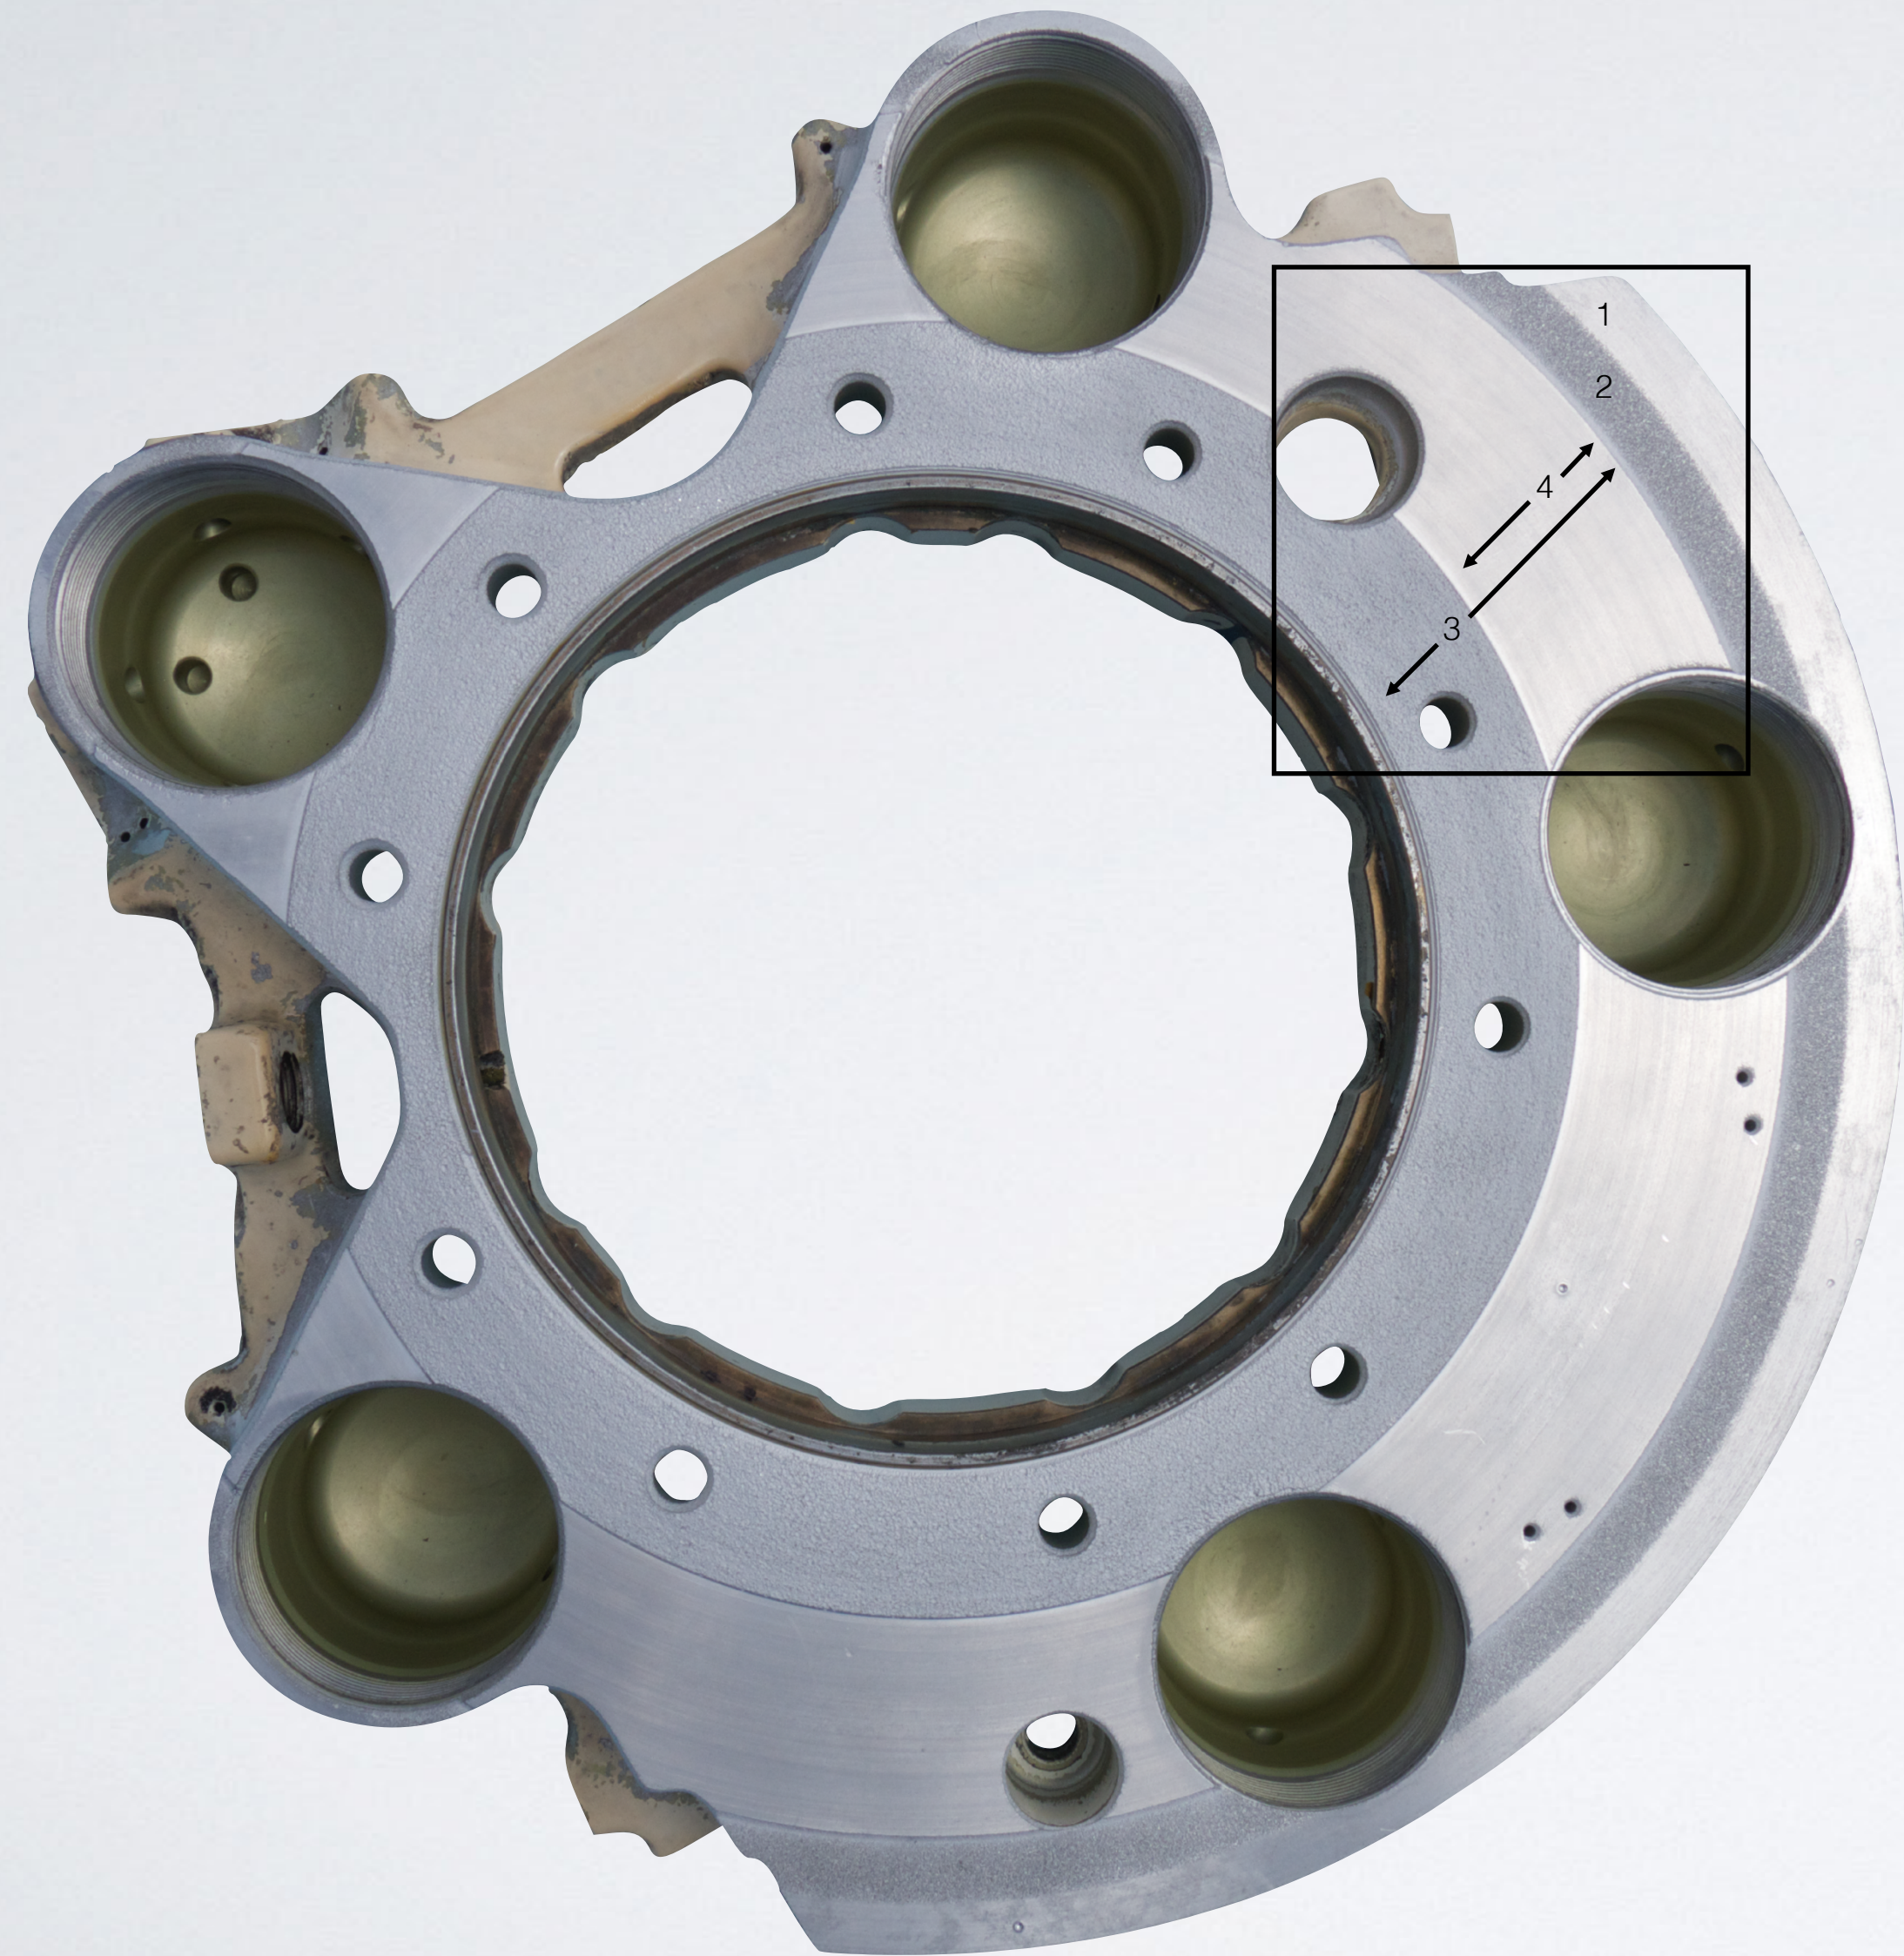
KM Repair F/A-18E/F Brake Carrier

1. Corroded and damaged surface machined down.
2. Surface prepared by grit-blast for KM Repair.
3. Kinetic Metallization repair as deposited.
4. KM repair as machined.

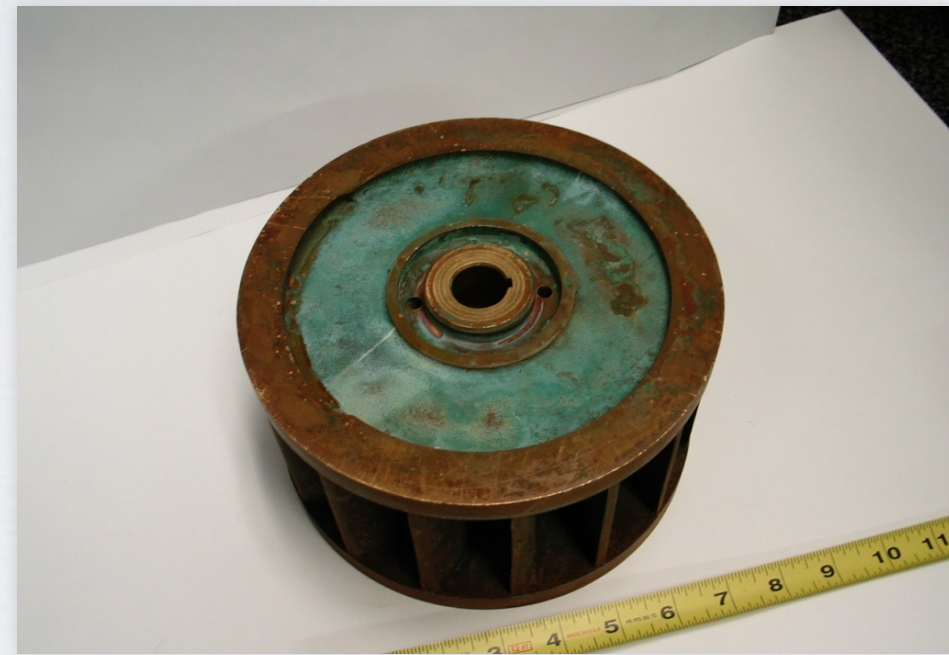
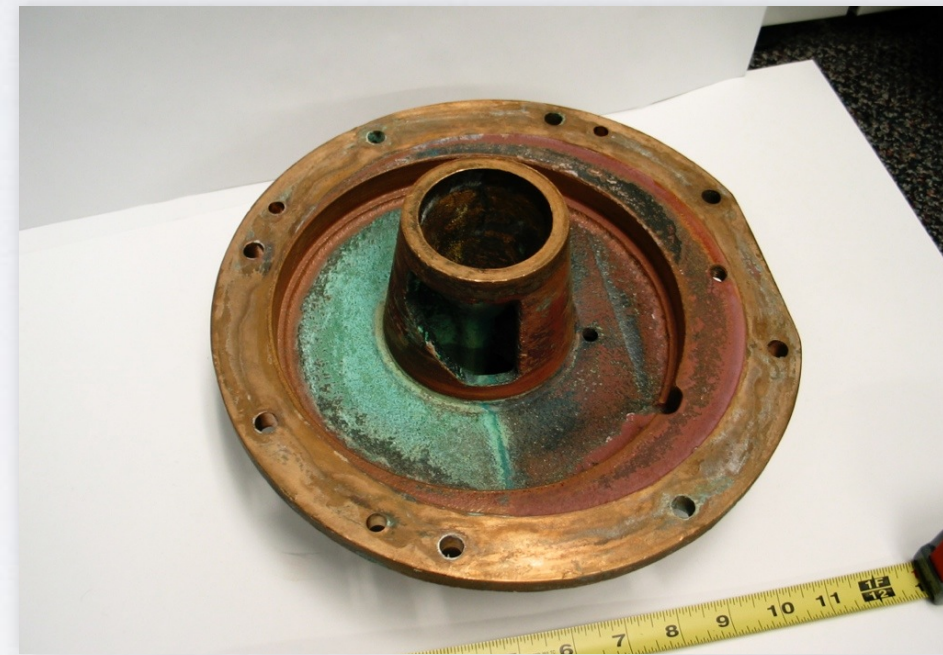
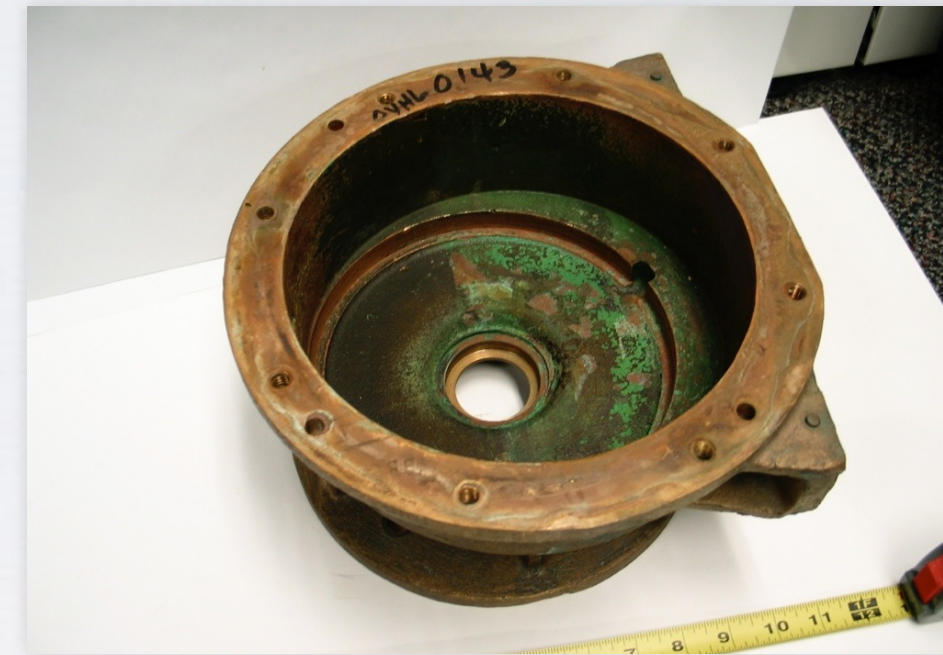
PROBLEM

- Corrosion
- Erosion
- Wear

- **Unobtainable**

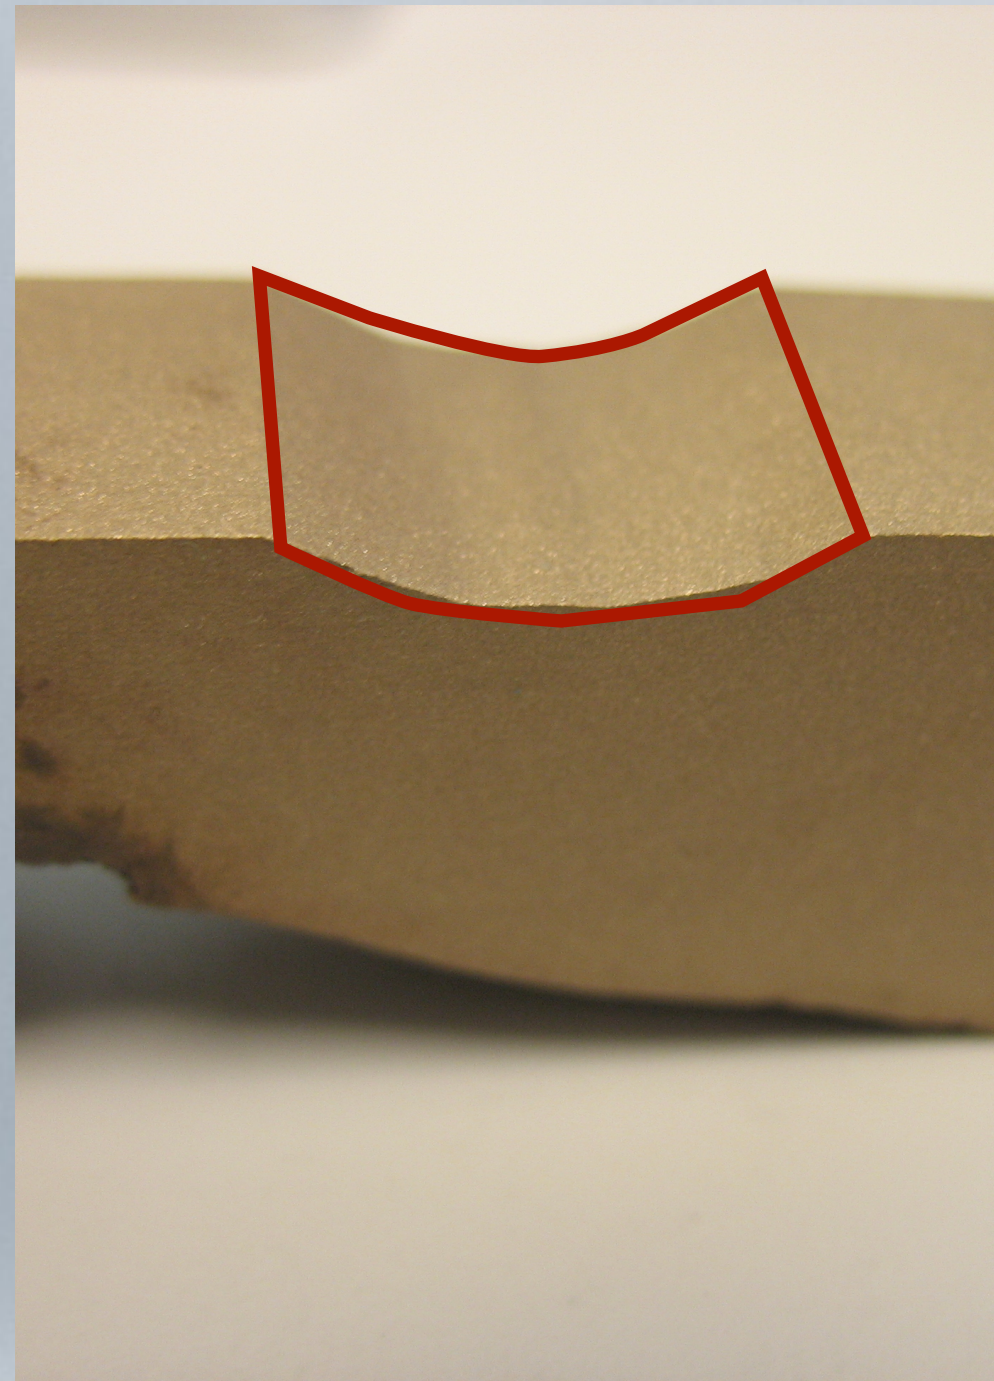
C92200 Simulated
damage:
machined groove, slope
2:1

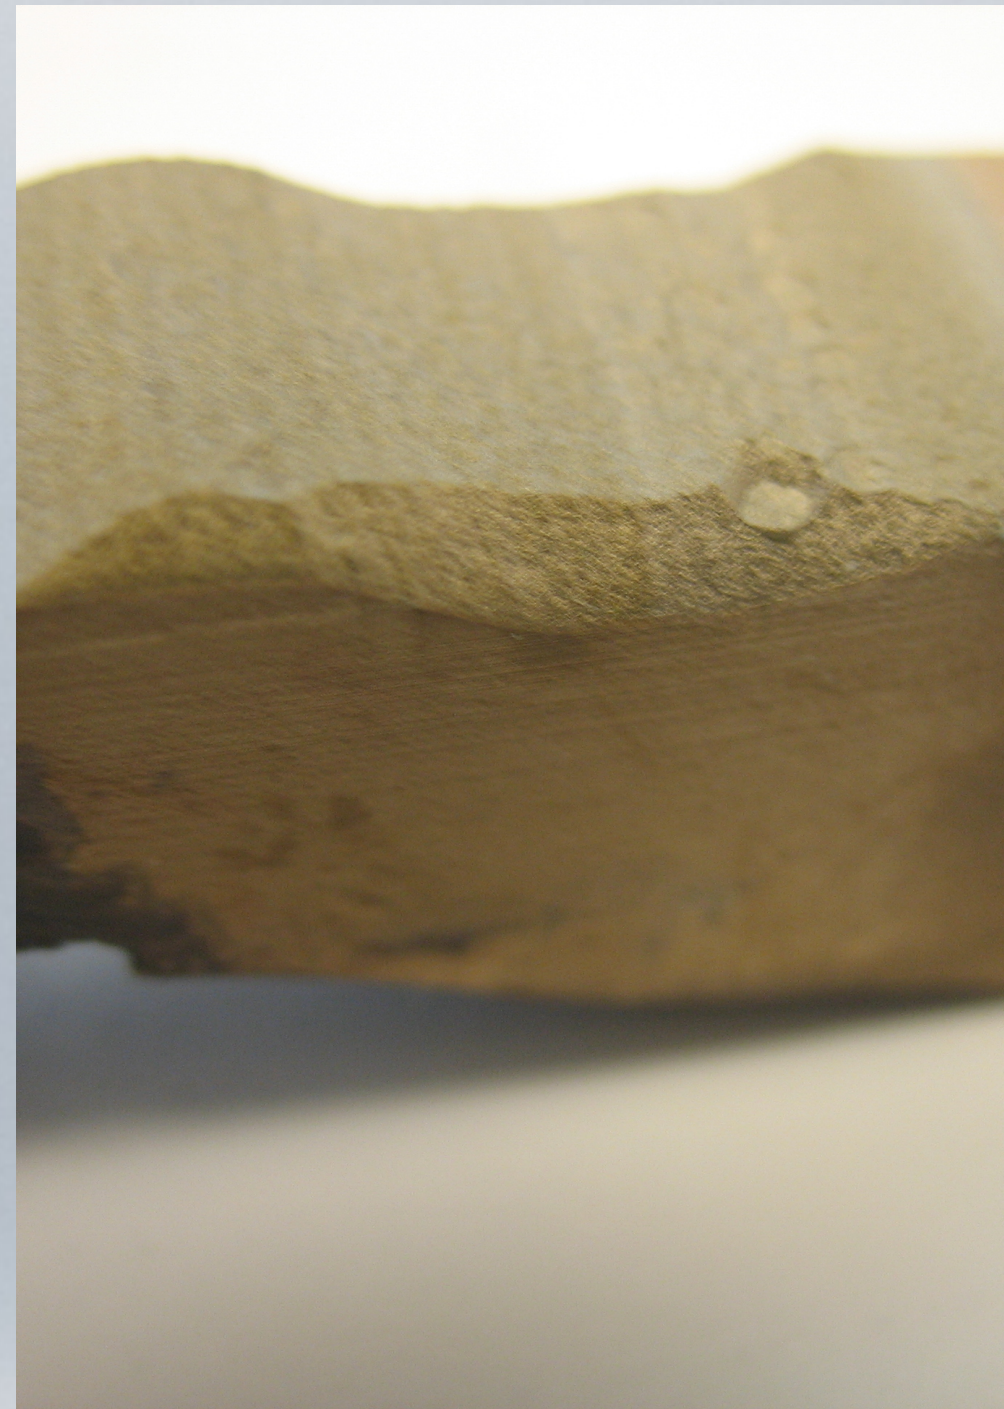
KM deposit, ABI Bronze
repair material

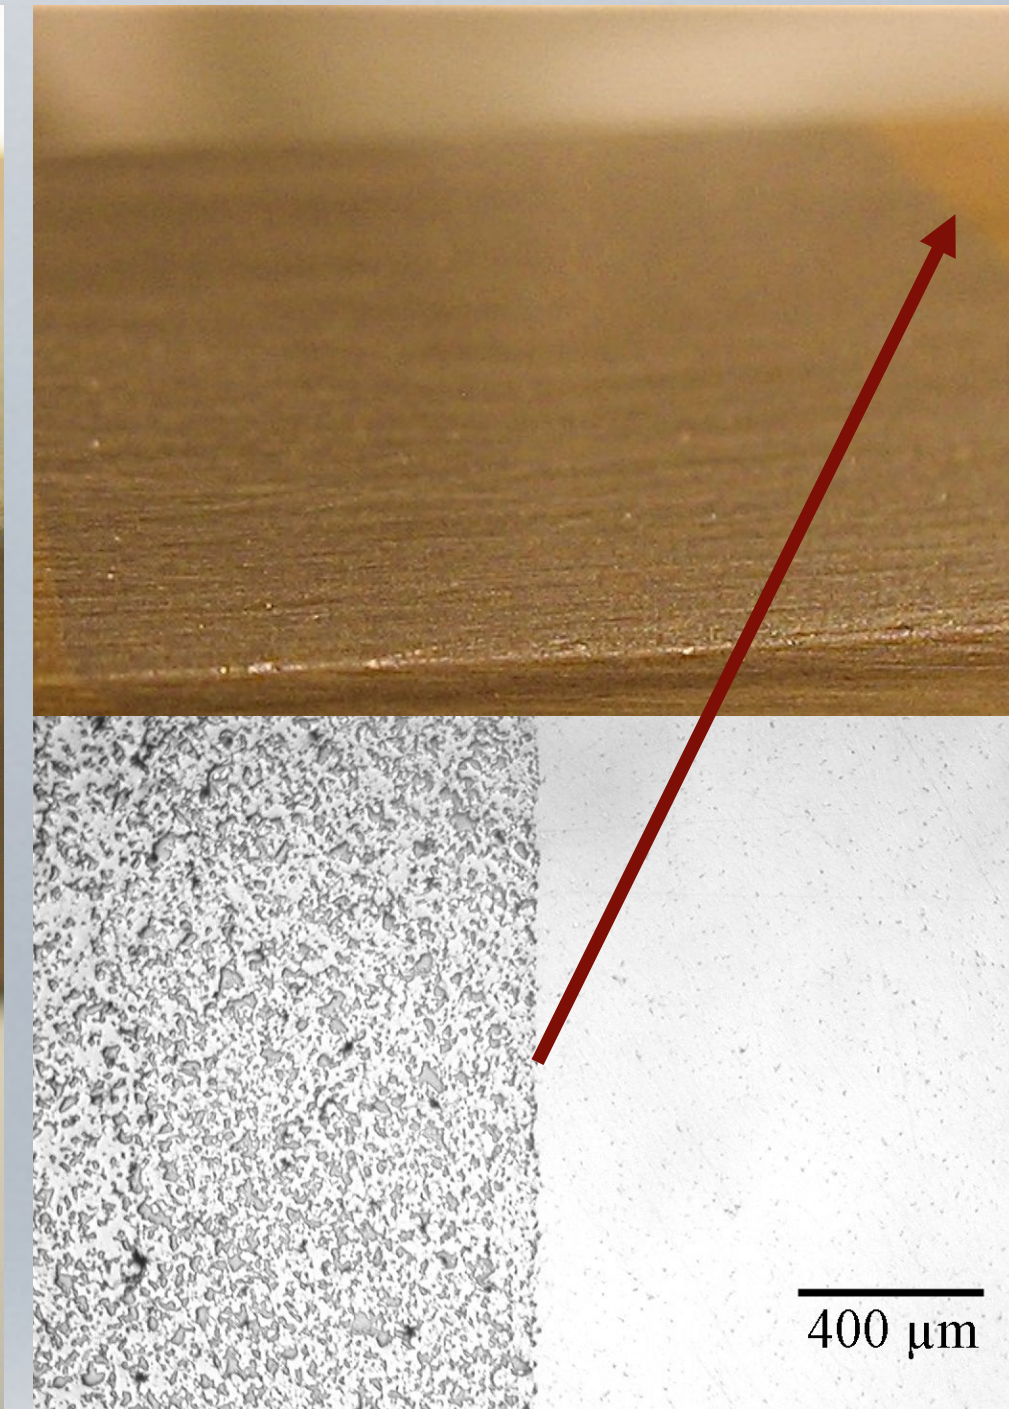
Excess repair material
removed (as ground)
