### Kinetic Metallization<sup>™</sup> Naval Weapon System Repairs

Presented to: NAVAIR Fleet Readiness Center East

> Presented by: Howard Gabel www.inovati.com

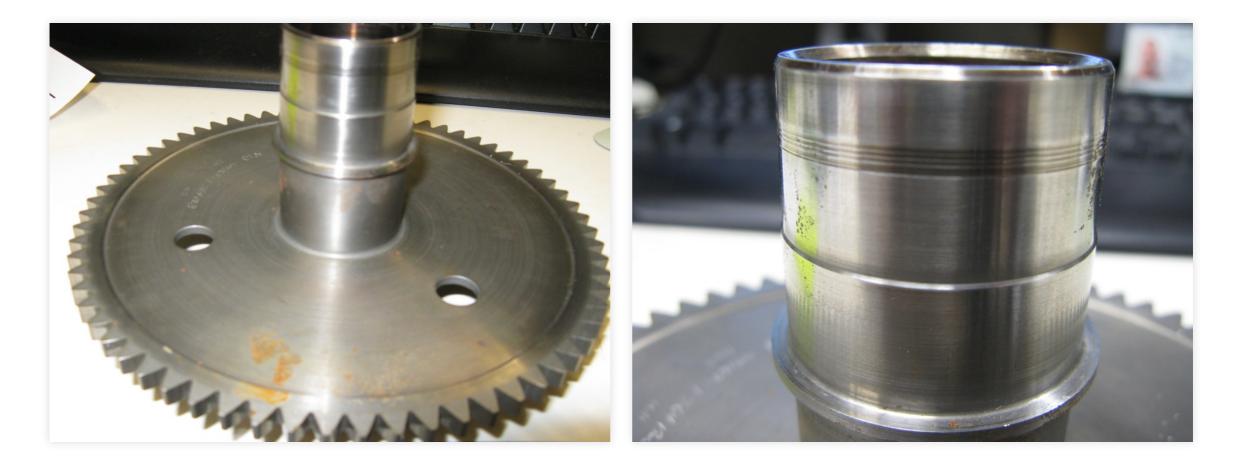
### Wear Groove

0.005" deep

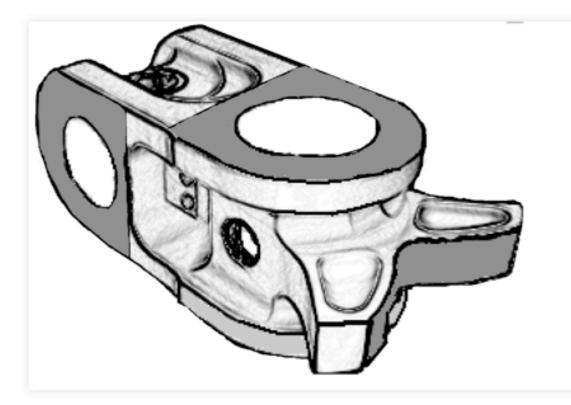
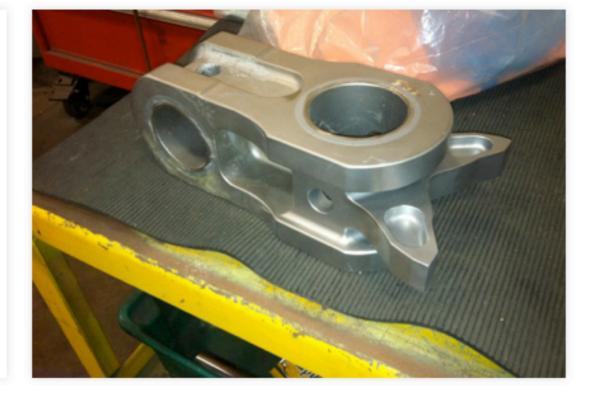
### F-18 Tailhook Arresting Gear Pivot

WC-Co Coating (shaded)  Photo of Arresting Gear Pivot

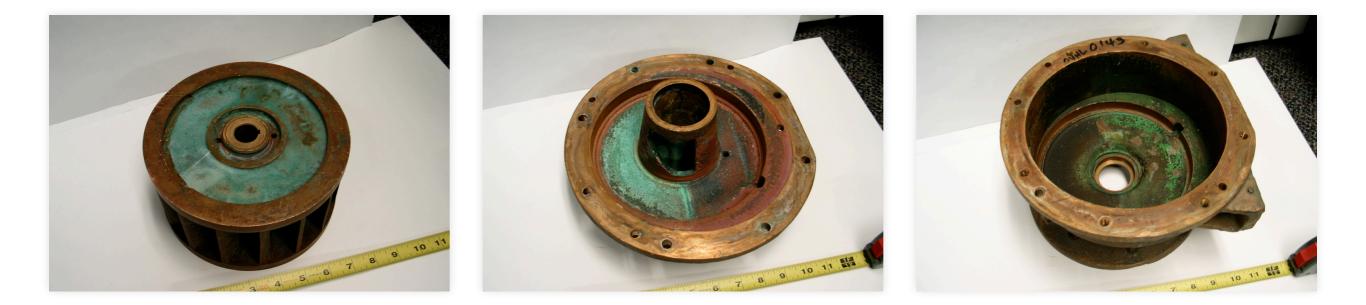
### Problem

- Corrosion
- Erosion

- ✤ Wear
- Unobtaintable

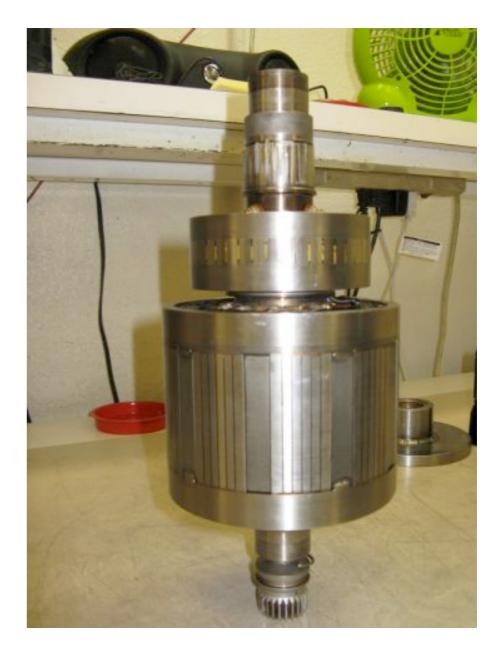
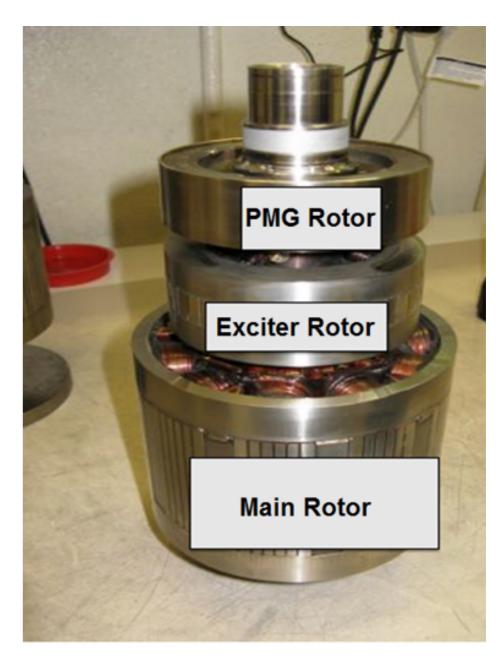
# Damage Areas

\* Тор

- Beneath Permanent Magnetic Group
- Bottom
  - Journal Bearing Area

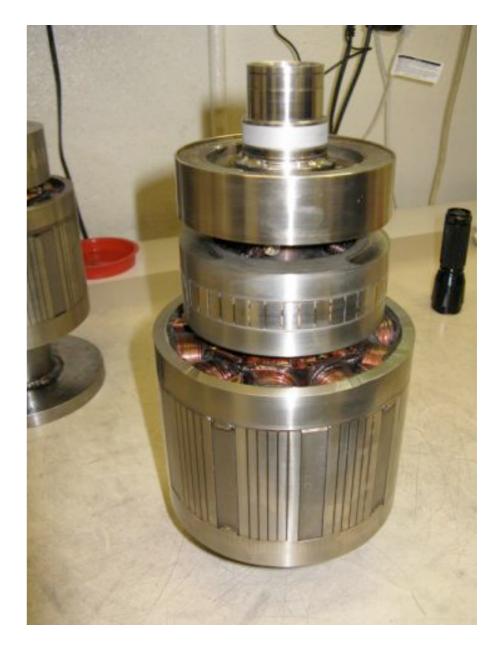
# Journal Damage

- Common failure
  - Bearing seizes
  - Sufficient torque to continue rotation
  - Shaft damaged

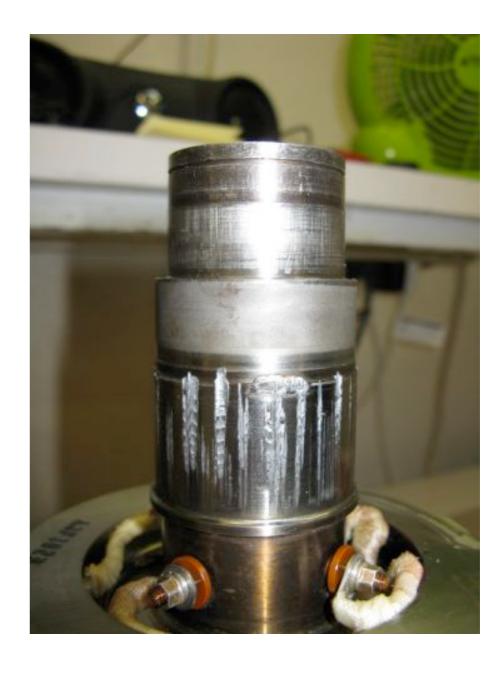
### Antidrive End

- PMG removal damage
- Diminutional restoration
